**Flood Control Project Maintenance  
Levee Inspections**

**Fall 2013 Levee Maintenance Deficiency Summary Report**

**Yolo County Planning Resources and Public Works**

Waterway			Bank	Unit Miles
Unit No. 01 Right Bank Cache Creek			Right	0.29
	Spring (March - May)	Summer (June - August)	(September - November) Fall	Winter (December - February)
Unit Maintenance Rating (Fall Only)			U	
Date of Inspection	-		10/22/2013 - 10/22/2013	
DWR Inspector	John Williamson		John Williamson	
Accompanied By

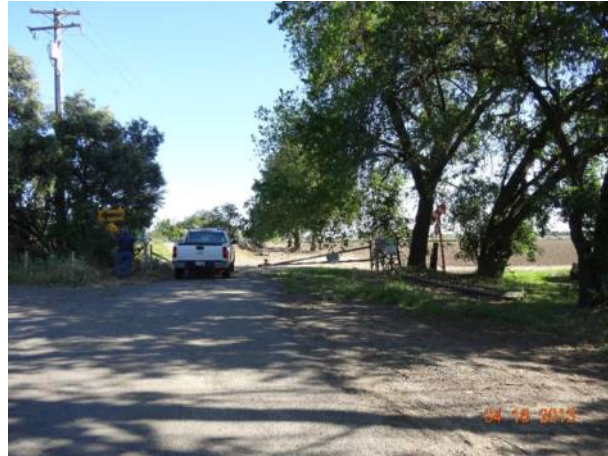
Levee Mile Report Line	5
Start Levee Mile	0.00
End Levee Mile	0.00
Location	Water Side
Category	Supplemental
Item	DWR UCIP Field Study

View of landward side near access gate. Gas line marker located on between trees. Line runs parallel to access roadway and through levee.

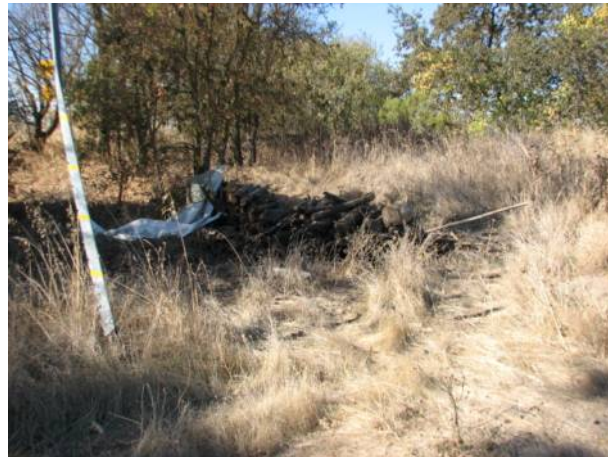
Levee Mile Report Line	6
Start Levee Mile	0.00
End Levee Mile	0.00
Location	Water Side
Category	Earthen Levee
Item	Encroachments

Firewood is stacked on the landside of the levee. Fall 2013

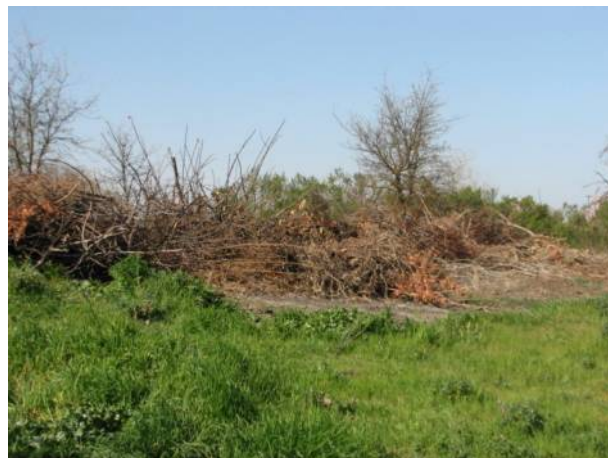
Levee Mile Report Line	7
Start Levee Mile	0.01
End Levee Mile	0.01
Location	Water Side
Category	Earthen Levee
Item	Encroachments

A continuous brush pile on levee. Spring 2013

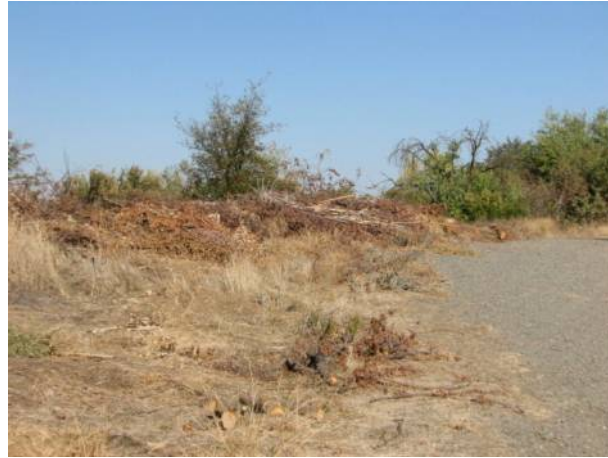
Levee Mile Report Line	7
Start Levee Mile	0.01
End Levee Mile	0.01
Location	Water Side
Category	Earthen Levee
Item	Encroachments

The latest look of the on going brush pile. Fall 2013

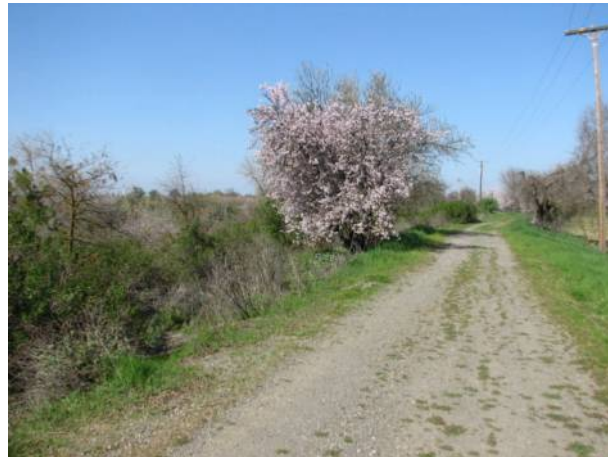
Levee Mile Report Line	8
Start Levee Mile	0.01
End Levee Mile	0.26
Location	Water Side
Category	Earthen Levee
Item	Vegetation

Vegetation and brush is taller than 12 inches. No visibility of the waterside berm. Spring 2013

8	0.01	0.26	Earthen Levee	Vegetation	WS U Ma	V2 : Remove the wild growth other than native grasses from the levee slopes.	38.722220 ° -121.806966 °	38.725887 ° -121.806550 °	17 Y
DWR ID: DWR_NA0021_01_s_2012_17									
9	0.03	0.03	Earthen Levee	Vegetation	WSA/W Ma	V4 : Elderberries are blocking visibility and flood fight capability.	38.722633 ° -121.806938 °	38.722633 ° -121.806938 °	14 Y
DWR ID: DWR_NA0021_01_s_2012_14

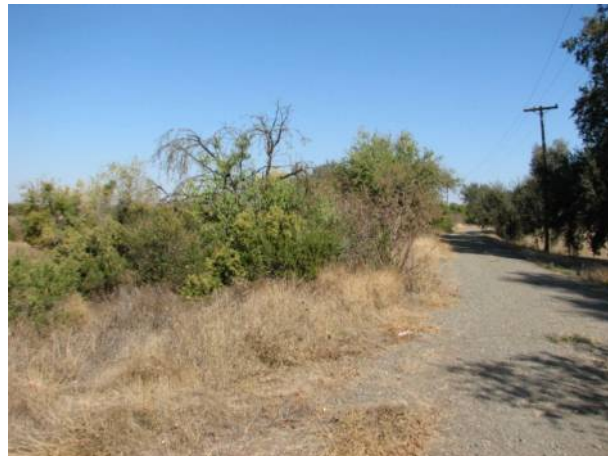
Levee Mile Report Line	8
Start Levee Mile	0.01
End Levee Mile	0.26
Location	Water Side
Category	Earthen Levee
Item	Vegetation

The vegetation on the waterside is over grown. Fall 2013

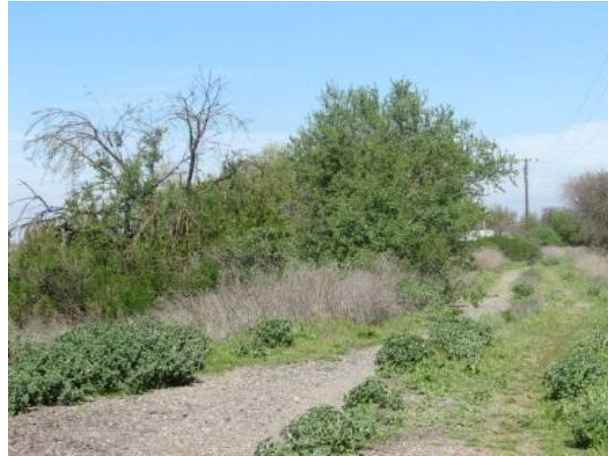
Levee Mile Report Line	9
Start Levee Mile	0.03
End Levee Mile	0.03
Location	Water Side
Category	Earthen Levee
Item	Vegetation
Photo taken spring 2012, a large Elerberry on the waterside.	
johngw_f_20131021_001.jpg

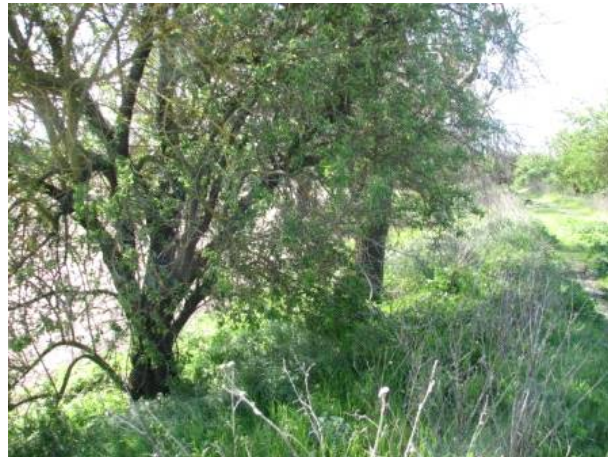
Levee Mile Report Line	10
Start Levee Mile	0.03
End Levee Mile	0.06
Location	Land Side
Category	Earthen Levee
Item	Trim / Thin Trees
The trees need to be thinned and trimmed up for visibility.	
johngw_f_20131021_003.jpg

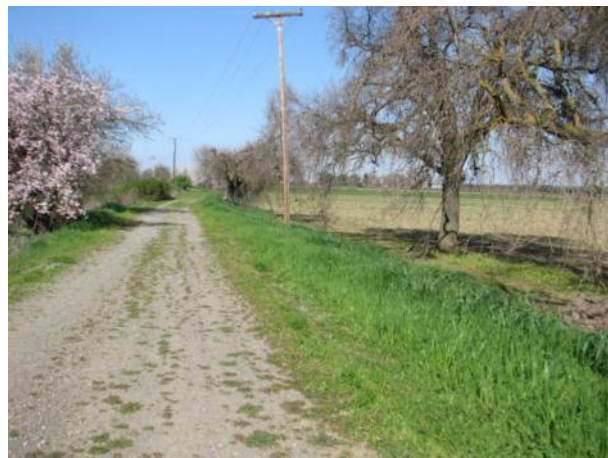
Levee Mile Report Line	11
Start Levee Mile	0.08
End Levee Mile	0.26
Location	Land Side
Category	Earthen Levee
Item	Vegetation
Vegetation needs to be mowed taller than 12". Spring 2013	
johngw_f_20131021_993.JPG

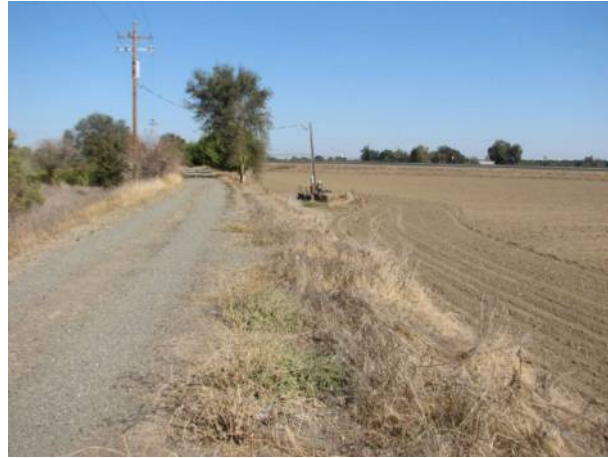
Levee Mile Report Line	11
Start Levee Mile	0.08
End Levee Mile	0.26
Location	Land Side
Category	Earthen Levee
Item	Vegetation

The vegetation partially blocking visibility. Fall 2013

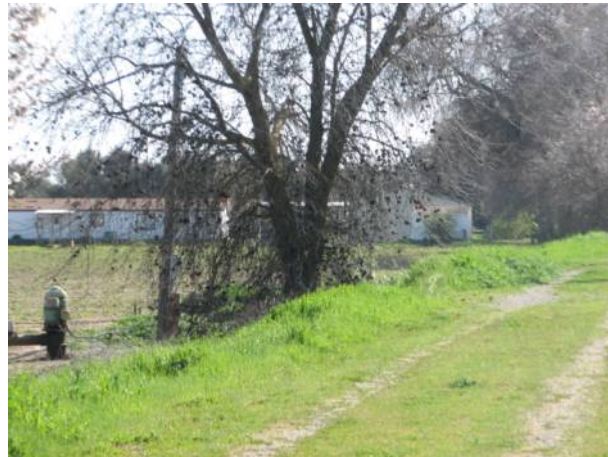
Levee Mile Report Line	12
Start Levee Mile	0.13
End Levee Mile	0.13
Location	Land Side
Category	Earthen Levee
Item	Trim / Thin Trees

Tree needs to be trimmed up 5'. Spring 2013

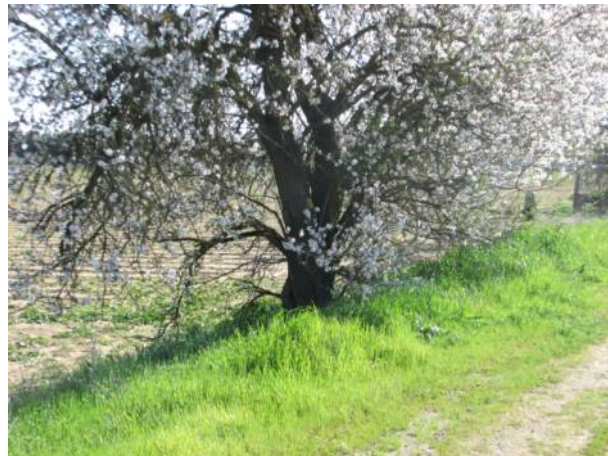
Levee Mile Report Line	13
Start Levee Mile	0.15
End Levee Mile	0.15
Location	Land Side
Category	Earthen Levee
Item	Trim / Thin Trees

Tree needs to be trimmed to 5'. Spring 2013

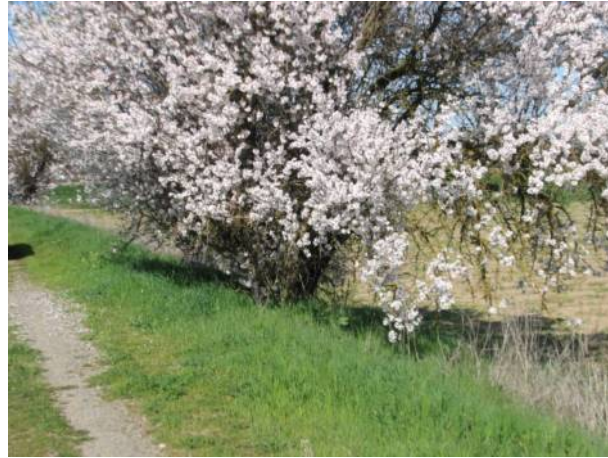
Levee Mile Report Line	14
Start Levee Mile	0.17
End Levee Mile	0.17
Location	Land Side
Category	Earthen Levee
Item	Trim / Thin Trees

Trees need to be trimmed to 5'. Spring 2013

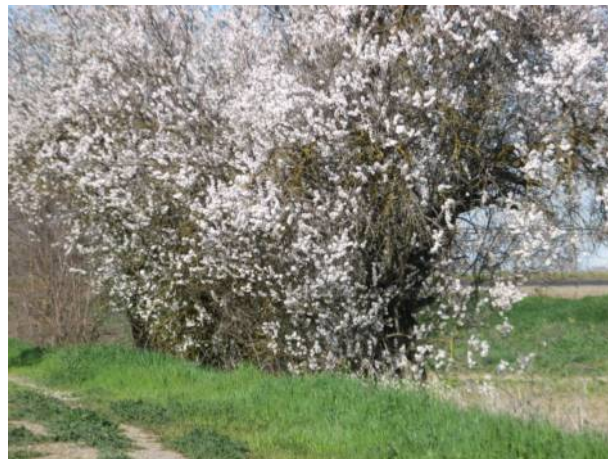
Levee Mile Report Line	15
Start Levee Mile	0.21
End Levee Mile	0.21
Location	Land Side
Category	Earthen Levee
Item	Trim / Thin Trees

Trees need to be trimmed to 5'. Spring 2013

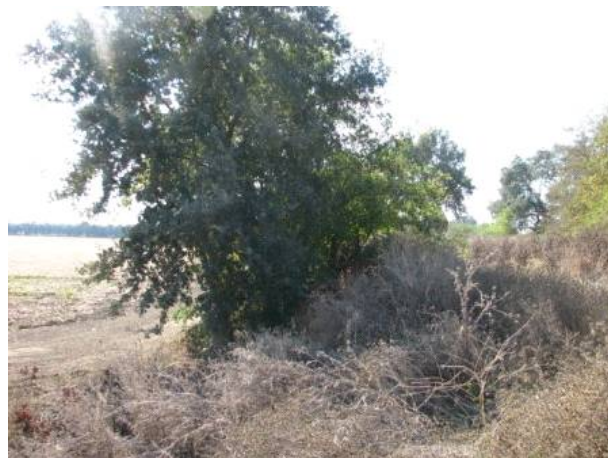
Levee Mile Report Line	16
Start Levee Mile	0.24
End Levee Mile	0.24
Location	Land Side
Category	Earthen Levee
Item	Trim / Thin Trees

The tree needs to be trimmed up. Photo taken fall of 2011.
